ADOBE IN ART-NOUVEAU CONSTRUCTIONS IN AVEIRO

Cristina Oliveira¹, Humberto Varum², Aníbal Costa³

Title: Raw materials and Art Nouveau

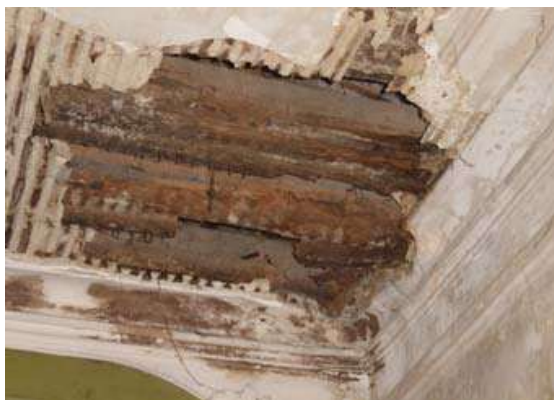
Due to moisture and infiltration, it is usual to find a strong degradation in wood elements, common in floors and roofs beams of these structures (Figure 2). The presence of water causes the swelling of the wood elements by installing a tension state giving rise to bending, distortion and cracking [Arriaga, F. et al (2002)]. In addition, the water makes the environment favourable to the development of biological agents whose action causes the degradation of wood. High degrees of degradation may also affect the binding of the floor and roof joists to the walls structures, placing at risk building safety.

Figure 2 – Deteriorating wooden beams floor ([Varum, H. et al (2005b)])

In the delivery zone of the floor wooden beams and respective support structures, adequate ventilation must be ensured to prevent the development of biological agents which could cause deterioration of the timber frame.

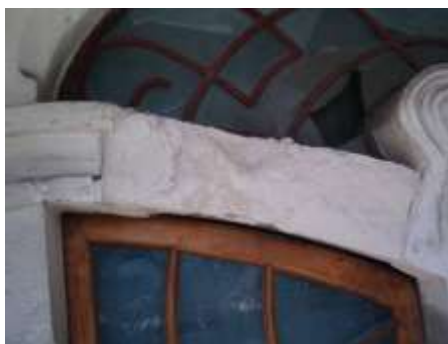
The facades of some of these constructions used stone, which may bring specific pathologies. Depending on the type of stone used, it may present different levels of degradation (Figure 3). Porous and permeable rock such as limestone, to provide circulation of water therein, is functioning as transport vehicle for damaging chemical agents for stone itself and to other construction elements.

Figure 3 – Advanced state of degradation of a limestone façade ([Varum, H. et al (2008a)])

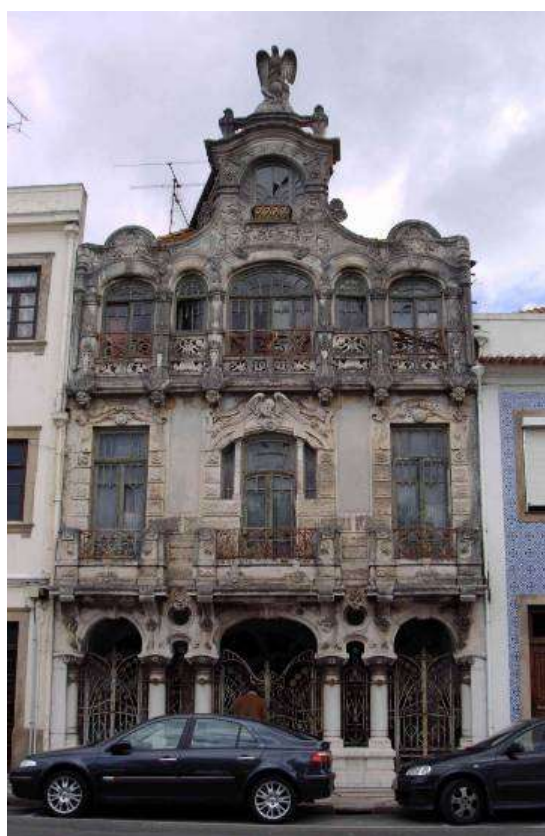
At the time, the numerous pathologies present were due mainly to lack of maintenance. Infiltration, deterioration of the wooden structure, local crushing on the resistant walls, deformations of the façades, were, among others, some of the problems observed, which were questioning the durability of the building and even its overall stability (Figure 5).

Figure 5 – Major Pessoa House: a) before the intervention [Varum, H. et al (2008b)], b) after the intervention
(photo: C. Oliveira)
